## DISTRICT OF HOPE

# Kawkawa Lake Road Bridge Repair and Replacement Options Report

September 9, 2004  
File: 022316

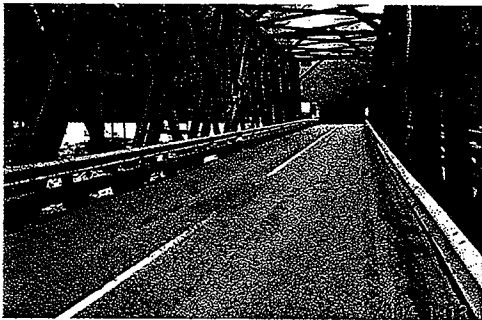
*Pothole on main span.*

In late 2003, a large pothole, approximately 0.5 m x 3 m formed near the road centreline of the east end main span. The cause of the ravelling in these areas has not been definitely confirmed. Probable causes include the local asphalt thickness, debonding of the membrane, and possibly local rot in the deck timbers. Over the winter of 2003/2004 this area has been maintained by patching with cold-mix asphalt. The cold mix repairs are not durable and a more permanent repair is required. A small area on the east approach span deck is also showing signs of cracking. The asphalt cracking here may lead to the formation of a pothole. Other minor asphalt cracking is occurring throughout the spans, which is normal for asphalt on timber decks.

An immediate repair to the potholes is needed. Three options are discussed below. Before, or as part of, any repairs, the condition of the deck timbers and the membrane at the location of the pothole should be confirmed.

The simplest patching option would be a plain hot-mix asphalt patch. Before installing the patch, the asphalt adjacent to the pothole would be removed over the full width of the deck. The edges of the patch should be cut vertical, as feathered patch edges will delaminate easier and reduce the life of the patch. The deck timbers and membrane should be checked and repaired as described above. The patch should have a maximum thickness of 50 mm with the edges tapered to match the existing.

We recommend that the plain asphalt patch described in Section 3.1 be implemented at this time over a liquid membrane. Generally, the deck asphalt is in fair to good condition. Replacing the deteriorated areas with a 50 mm thick patch should provide a durable repair.
